DEPARTMENT OF TRANSPORTATION**DIVISION OF ENGINEERING SERVICES**

Contract #: 04-0120F4Cty: SF/ALA Rte: 80 PM: 13.2/13.9File #: 1.28**WELDING INSPECTION REPORT****Resident Engineer:**Siegenthaler, Peter**Address:** 333 Burma Road**City:** Oakland, CA 94607**Report No:** WIR-025355**Date Inspected:** 20-Jul-2011**Project Name:** SAS Superstructure**OSM Arrival Time:** 700**Prime Contractor:** American Bridge/Fluor Enterprises, a JV**OSM Departure Time:** 1530**Contractor:** American Bridge/Fluor Enterprises, a JV**Location:** Job Site**CWI Name:** William Sherwood**CWI Present:** Yes No**Inspected CWI report:** Yes No N/A**Rod Oven in Use:** Yes No N/A**Electrode to specification:** Yes No N/A**Weld Procedures Followed:** Yes No N/A**Qualified Welders:** Yes No N/A**Verified Joint Fit-up:** Yes No N/A**Approved Drawings:** Yes No N/A**Approved WPS:** Yes No N/A**Delayed / Cancelled:** Yes No N/A**Bridge No:** 34-0006**Component:** S.A.S. components**Summary of Items Observed:**

- 1) Field Splice welding at OBG 11W/12W
- 2) Submittal reviews at Pier 7

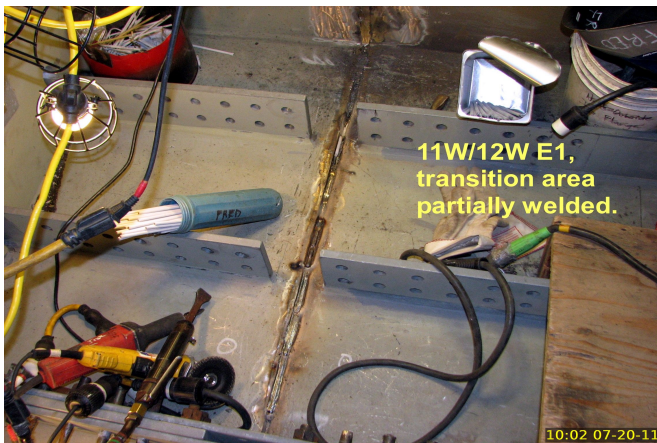
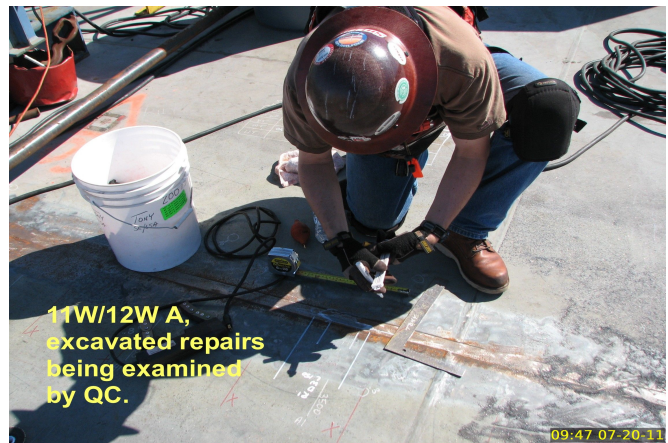
1)The QAI observed ABF personnel working at field splice 11W/12W welds A, B and F. The QAI noted that all work in being performed on the interior of the structure. The QAI noted that Quality Control Inspector (QCI) William Sherwood is monitoring this work. The QAI observed that at weld B, Jorge Lopez, ID 6149, is cleaning up the weld cover and grinding prior to visual inspection. At weld F, the QAI noted that the bottom transition to weld E is being welded by shielded metal arc welding (SMAW). The QAI also observed the QCI William Sherwood conducting magnetic particle testing (MT) on weld excavations for repairs in weld A. The QAI noted that all weld segments (A1 - A5) have repairs identified and are being excavated. This work was in progress at the end of the shift. See the attached photos.
